AM V Hi Pedal Flush Toilet 31,600 - 31,799

PART NUMBER L-1725	TITLE AM V Hi Pedal Customer Support Illustration		
	PRINTED MATERIAL	DRAWING DATE 12 July 2011	DRAWN BY TGC	CHECKED BY GG

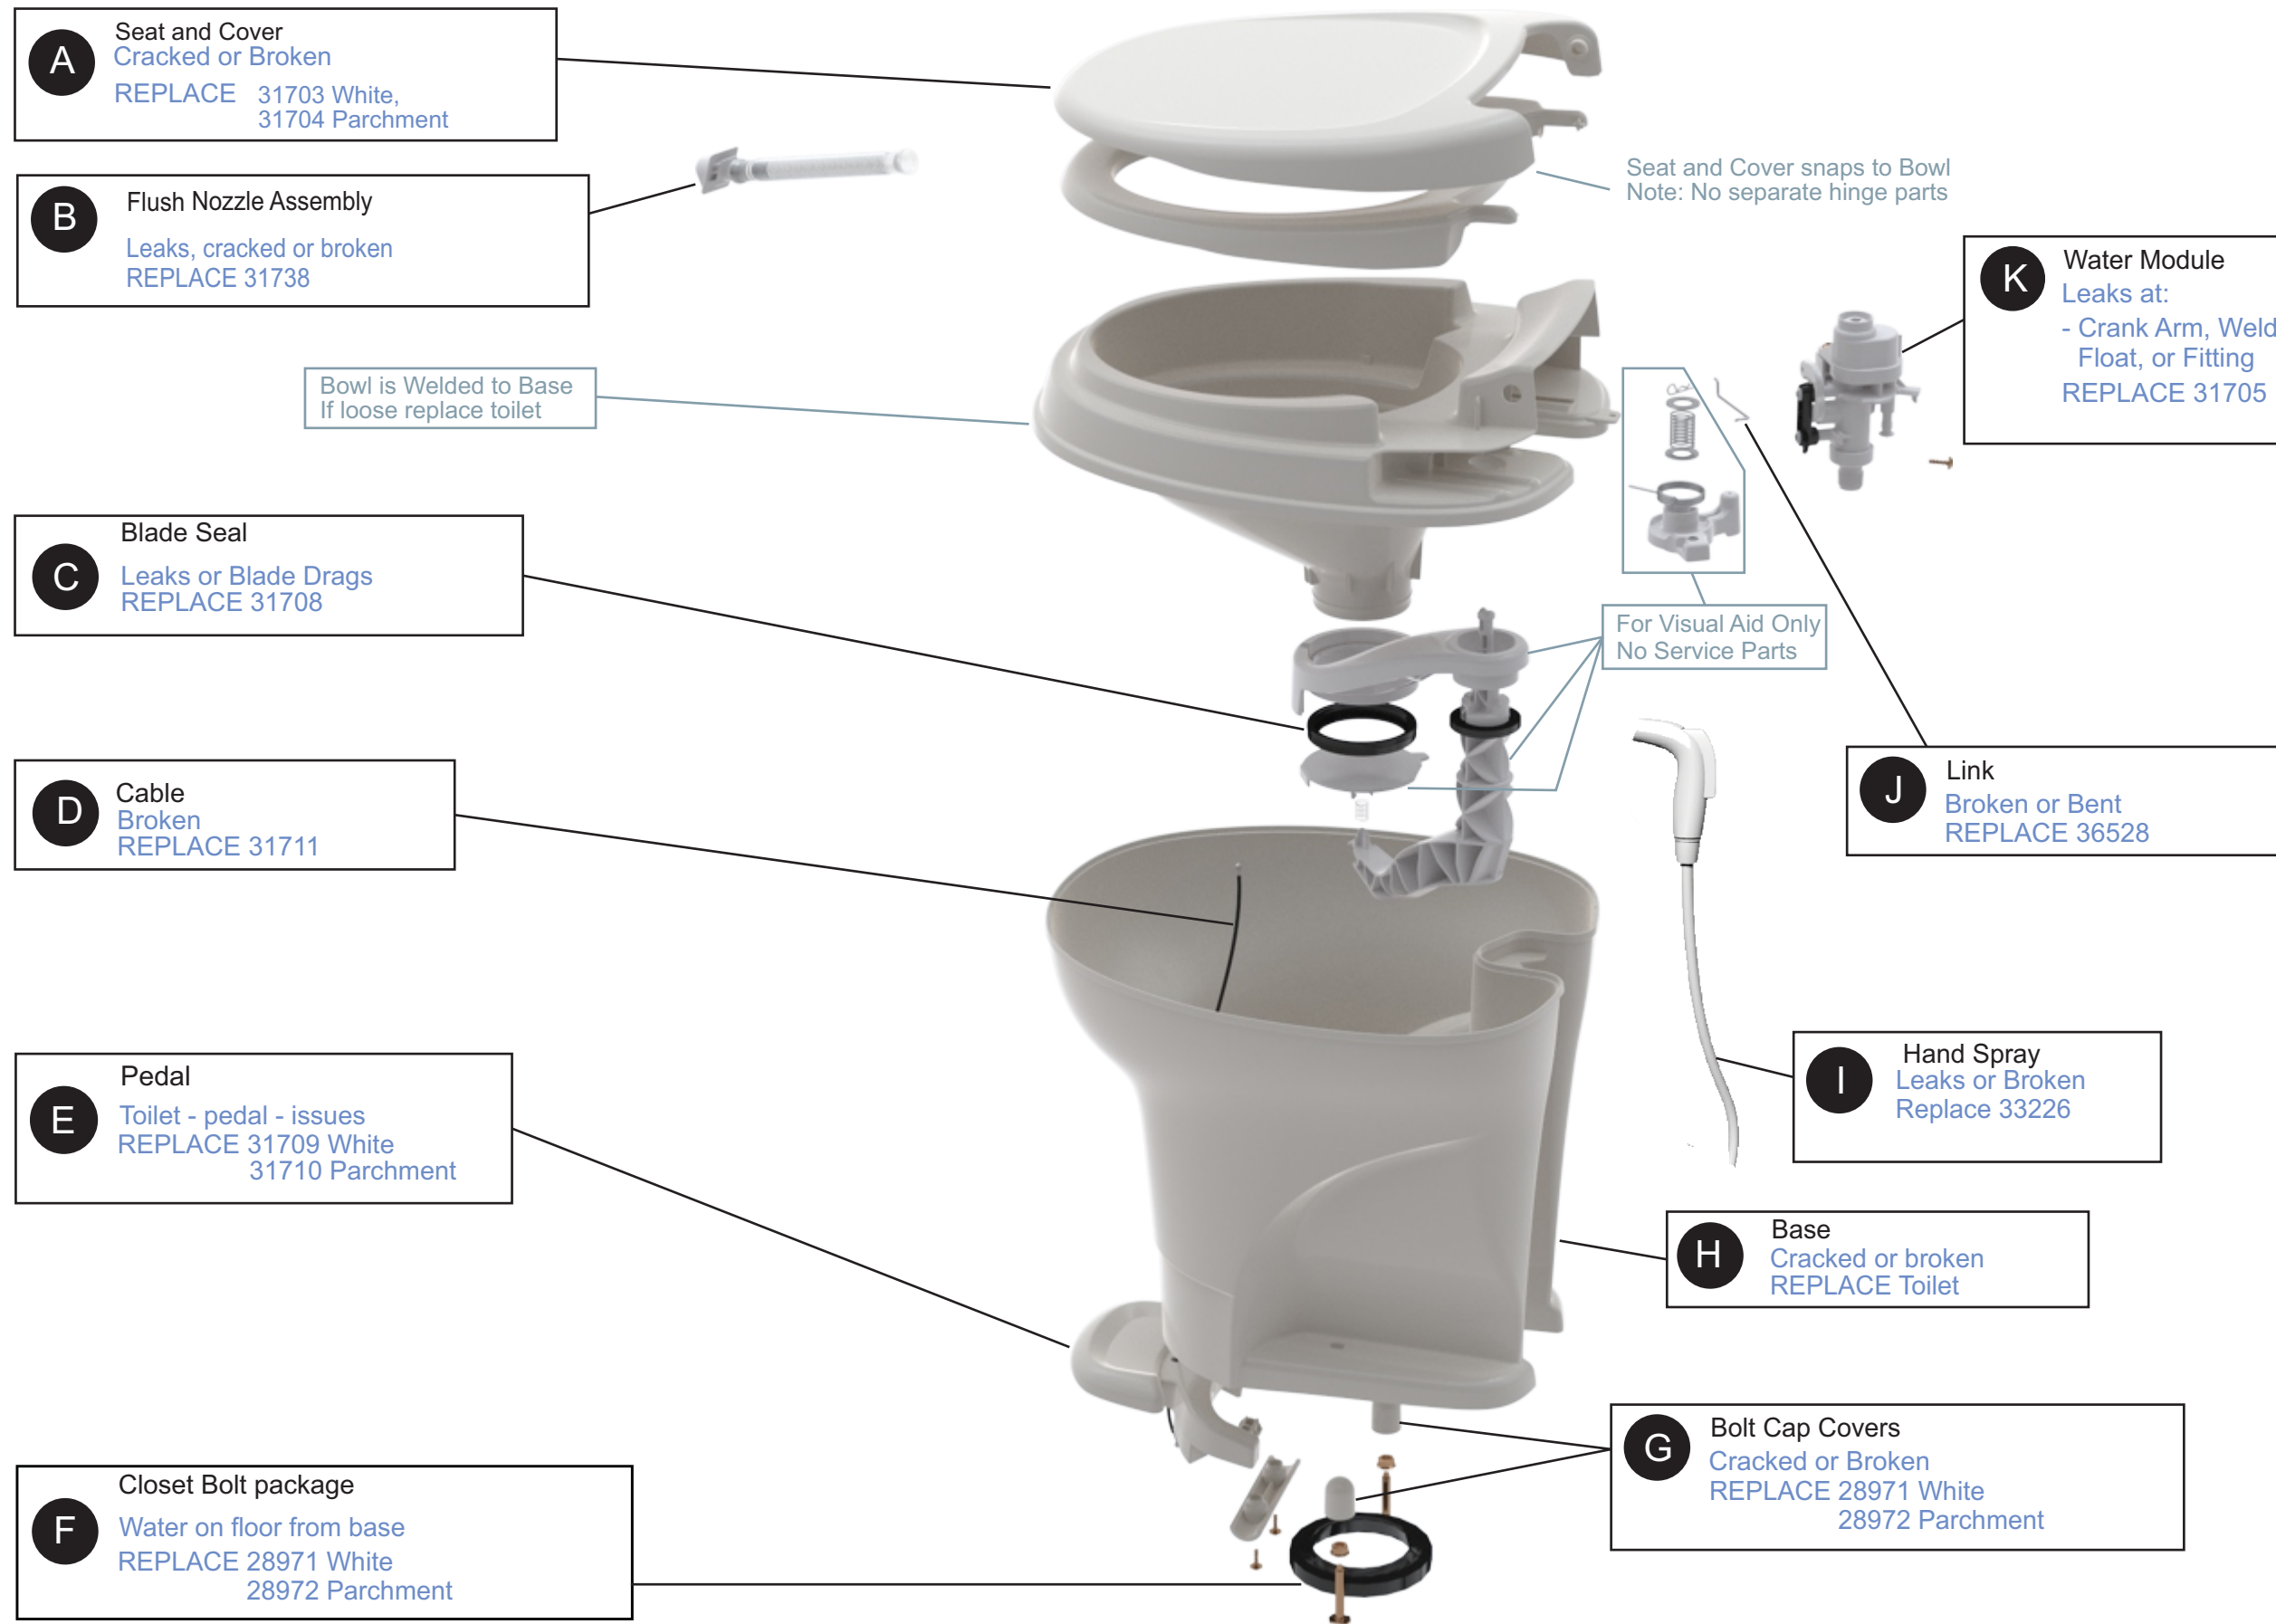
A Seat and Cover
Cracked or Broken
REPLACE 31703 White,
31704 Parchment

B Flush Nozzle Assembly
Leaks, cracked or broken
REPLACE 31738

Bowl is Welded to Base
If loose replace toilet

C Blade Seal
Leaks or Blade Drags
REPLACE 31708

D Cable
Broken
REPLACE 31711

E Pedal
Toilet - pedal - issues
REPLACE 31709 White
31710 Parchment

F Closet Bolt package
Water on floor from base
REPLACE 28971 White
28972 Parchment

Seat and Cover snaps to Bowl
Note: No separate hinge parts

K Water Module
Leaks at:
- Crank Arm, Weld Seam
Float, or Fitting
REPLACE 31705

J Link
Broken or Bent
REPLACE 36528

I Hand Spray
Leaks or Broken
Replace 33226

H Base
Cracked or broken
REPLACE Toilet

G Bolt Cap Covers
Cracked or Broken
REPLACE 28971 White
28972 Parchment

Note: Odor problems
- Make sure Bowl holds water

- Make sure vent pipes to
Holding Tank are not blocked
